Phase 1-2 Cultural Resources Study, Historic Resources

**83 Eucalyptus Lane (All Saints By-the-
Sea Church), Montecito, California
(APN 009-332-009)**

Post/Hazeltine Associates
2607 Orella Street
Santa Barbara, CA 93105
(805) 682-5751
posthazeltine@cox.net

August 27, 2015

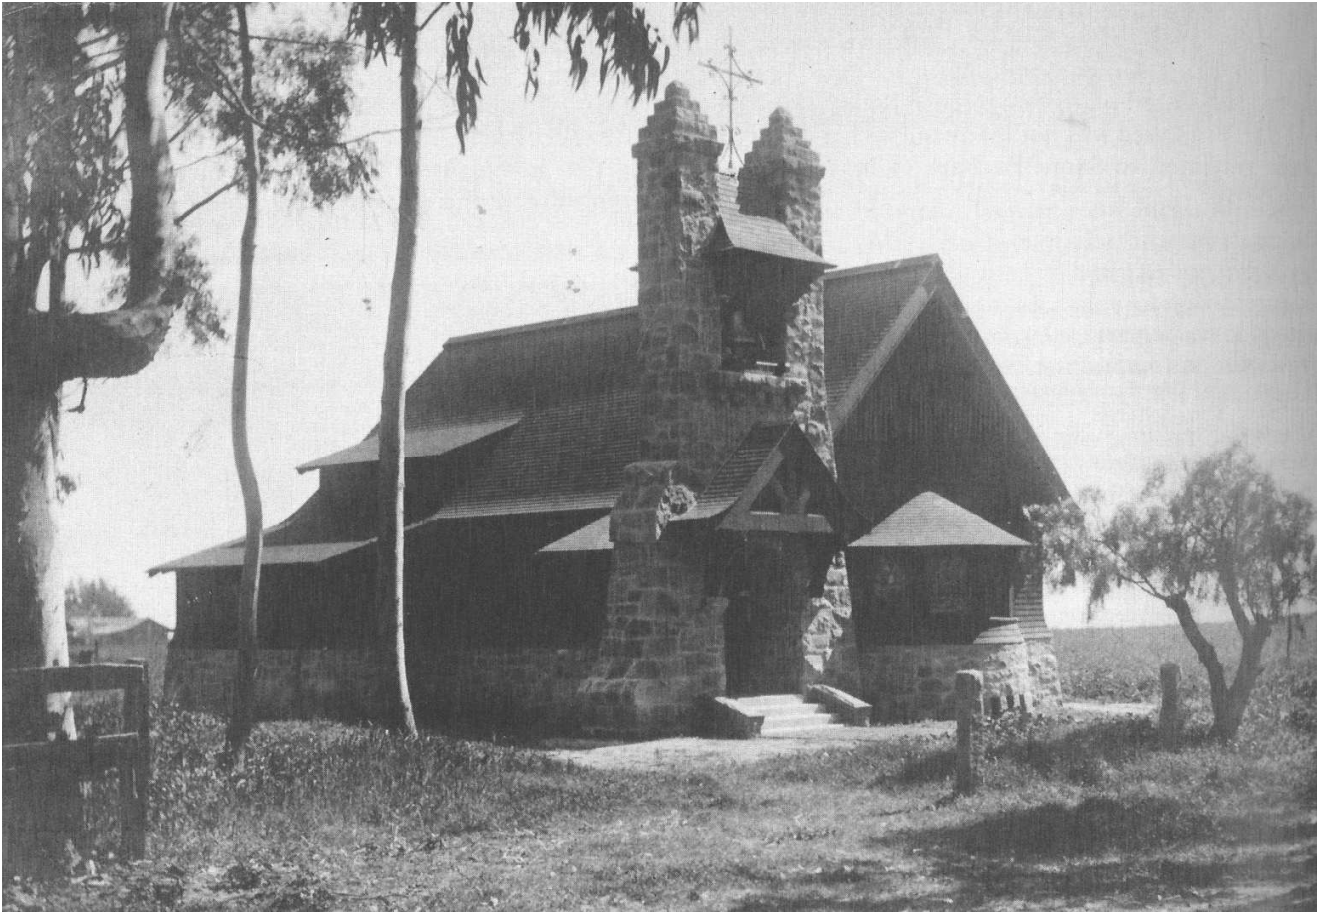
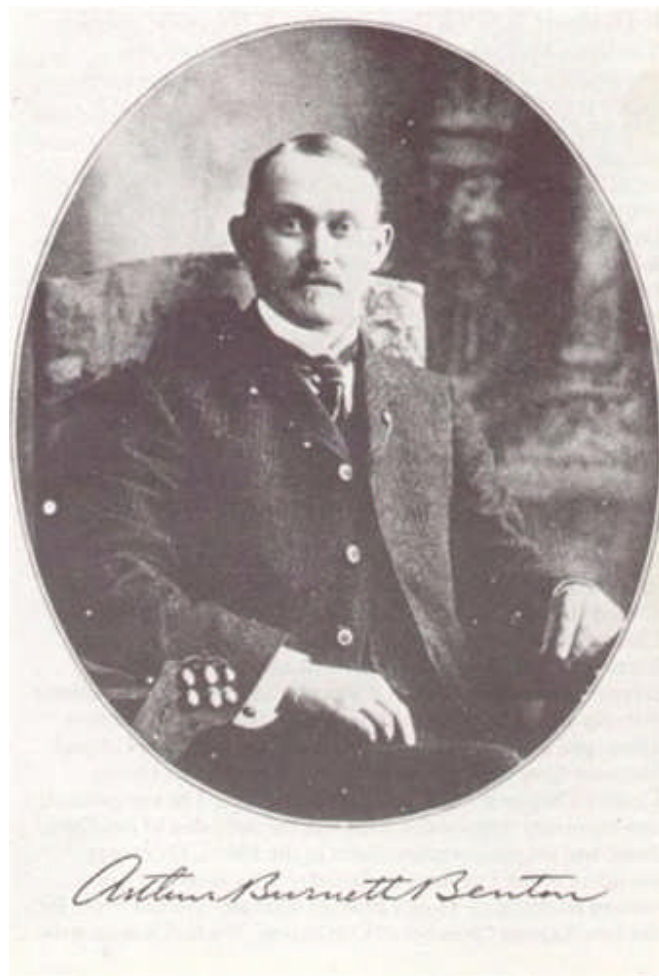
Figure 3
All Saints By-the-Sea Church at 83 Eucalyptus Lane in Montecito
Postcard of church shortly after completion
Circa-1900-1915 (postcard)

Figure 4
All Saints By-the-Sea Church at 83 Eucalyptus Lane in Montecito
Postcard of church shortly after completion
Circa-1900 (Myrick 1987: 130)

Originally, the recessed wing and secondary entrance flanking the south side of the nave was capped by a shed roof (see Figures 3 & 4). This wing was rebuilt with a front gable roof and a porch capped by open trusswork whose design emulated the roof over the main entrance to the church. The addition housed a study and choir room. The recessed wing at this end of the elevation was built in 1916.

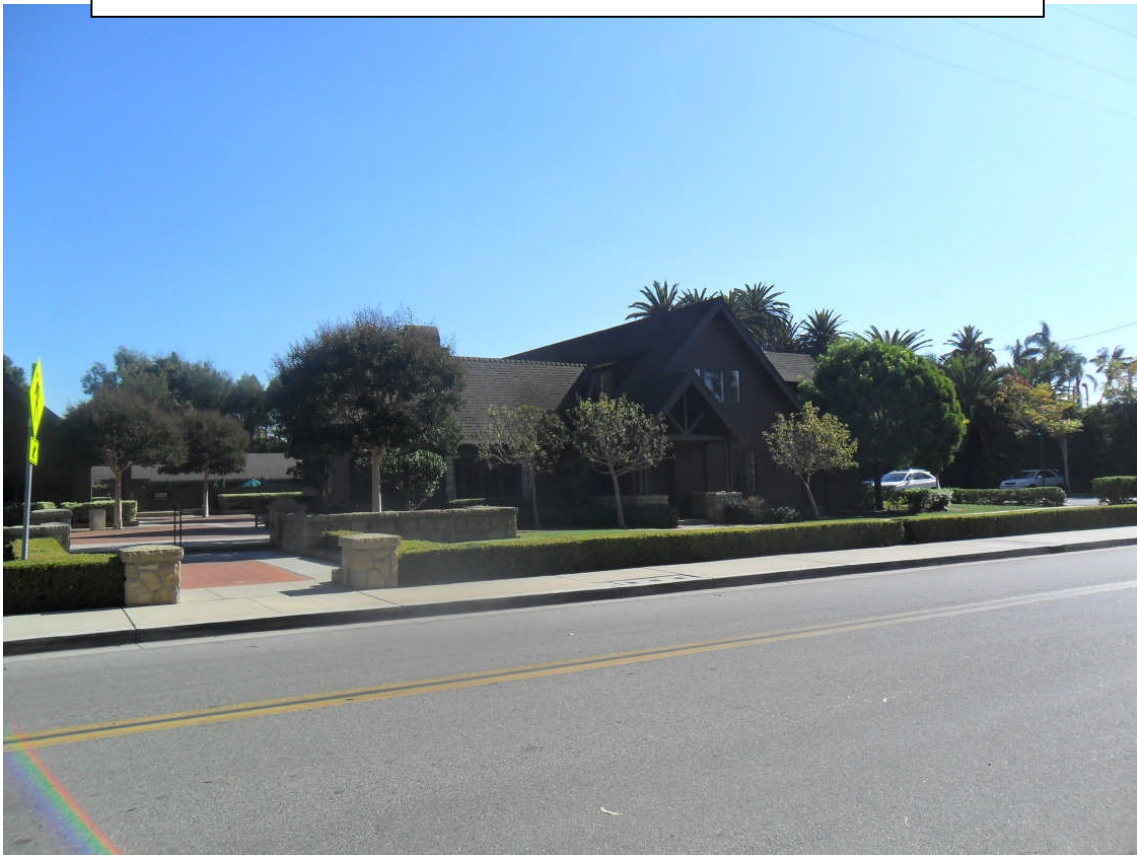
Figure 9
All Saints By-the-Sea Church at 83 Eucalyptus Lane, Montecito
Looking northeast

Improvements to the property include, in addition to the church (Figure 9), a detached Parish Hall (built 1929); a detached Centennial/Parish House (formerly the Rectory, built in 1934 and remodeled in 1998-1999); as well as a detached Friendship Center/Sunday School (originally built as a Sunday school in 1949, additions were made in 1951, 1958, with additions and renovations in 1998-1999) (Figures 10,10a & 10b). The property's designed landscape features a paved

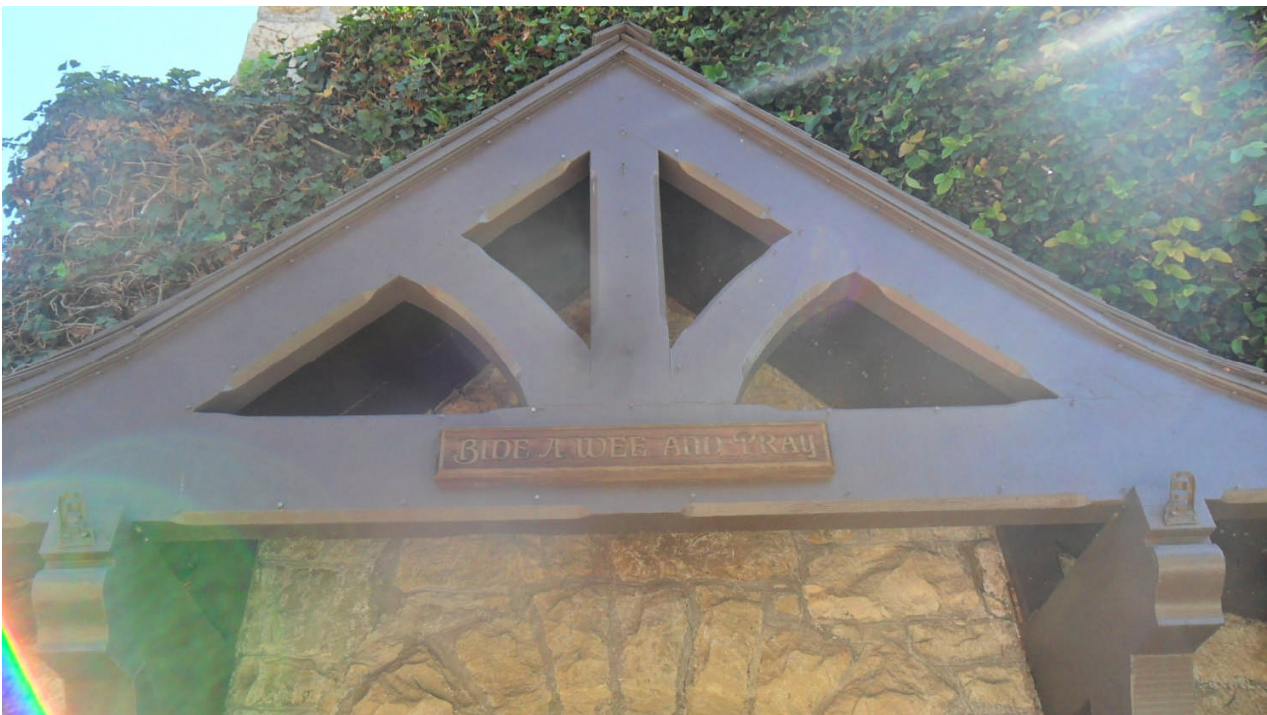
Figure 11
All Saints By-the-Sea Church at 83 Eucalyptus Lane, Montecito
West elevation of the church (primary façade)
Looking east

Built in 1900, the wood-framed and masonry Craftsman style church incorporates Gothic Revival style motifs (Figure 11). The church, which is essentially rectangular in configuration, is aligned on a west to east axis with the vestibule at its west end, opening into the narthex and baptistery. The narthex opens into the nave which extends east to the sanctuary, which is flanked on its south side by the vestry and a small chapel. The church's picturesque massing, composed of steeply pitched roofs and a masonry bell tower set at the northwest corner of the building, is designed to emphasize the domestic scale of the building which recalls the appearance and character of a rural Gothic Revival English church as filtered through the sensibilities of Arthur Benton's interpretation of the Craftsman style.

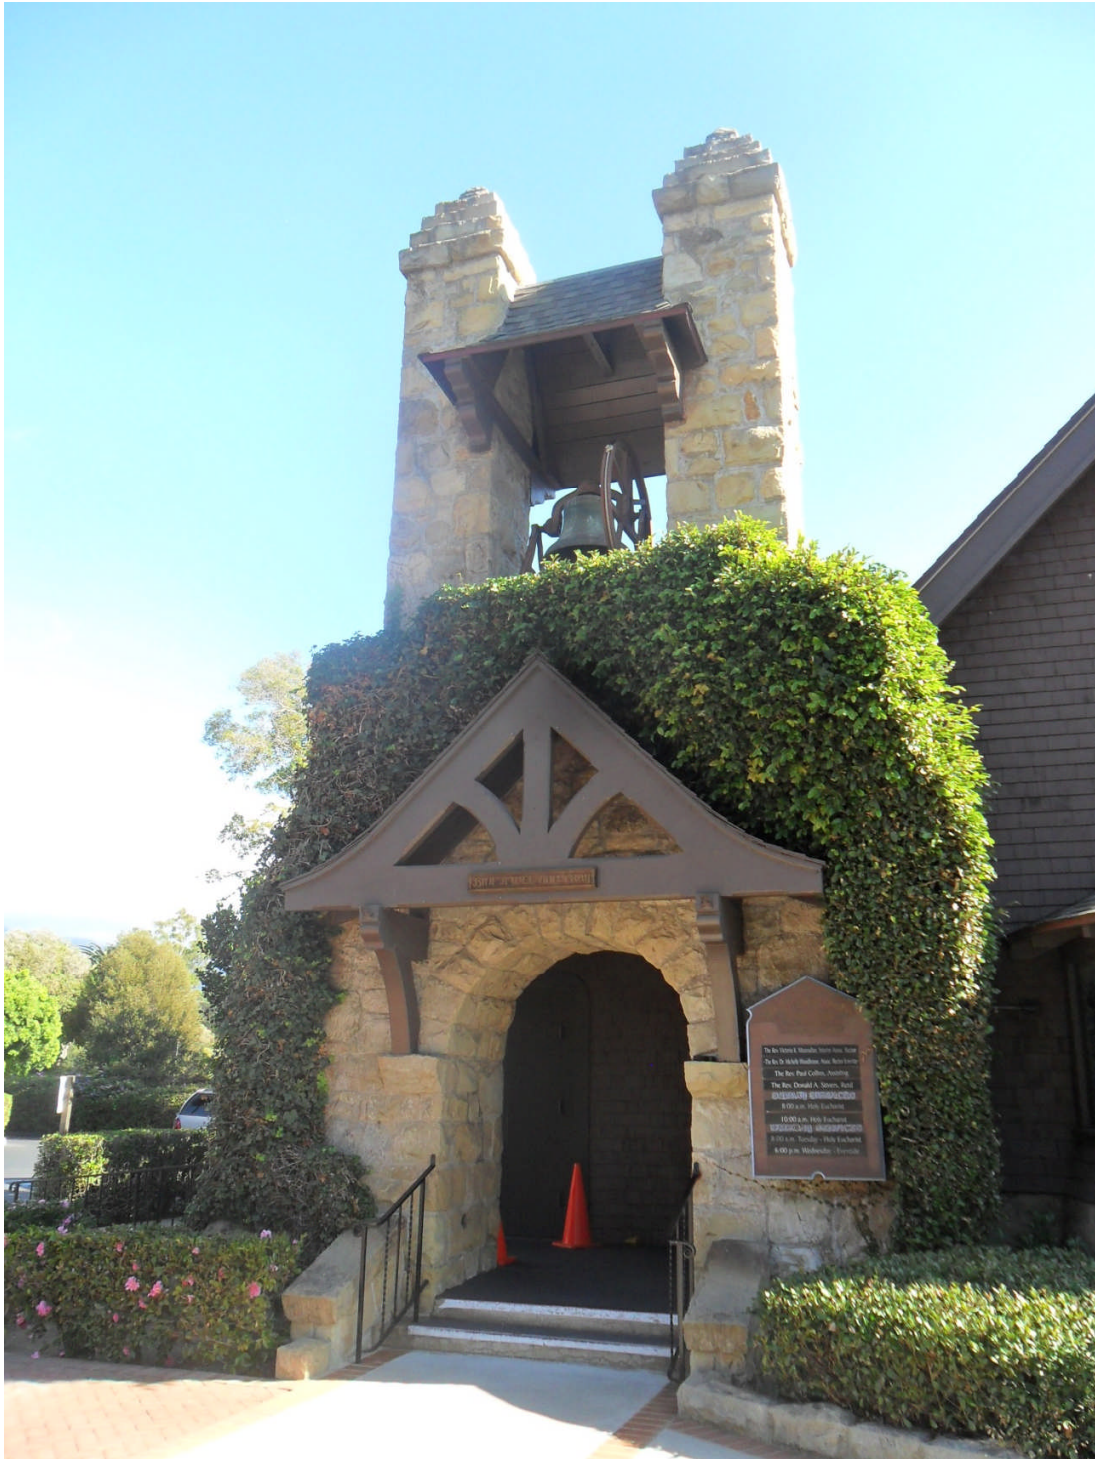
Figure 12
West elevation(primary façade), detail of porch roof
Looking east

The west elevation is the entrance façade of the building (Figures 12 - 14). Its picturesque massing is defined by the asymmetry of the elevation with the main front gable roof flanked on its north by a masonry bell tower composed of rectangular sandstone blocks housing a recessed entry porch at its base and a belfry. A series of steeply-pitched front gable roofs cap the main block of the church and the two recessed wings set off the south side of the elevation. The central gable is capped by a Celtic style cross. Wide wood plank fascias sheath the slightly projecting roof eaves. A semi-circular apse-like projection housing

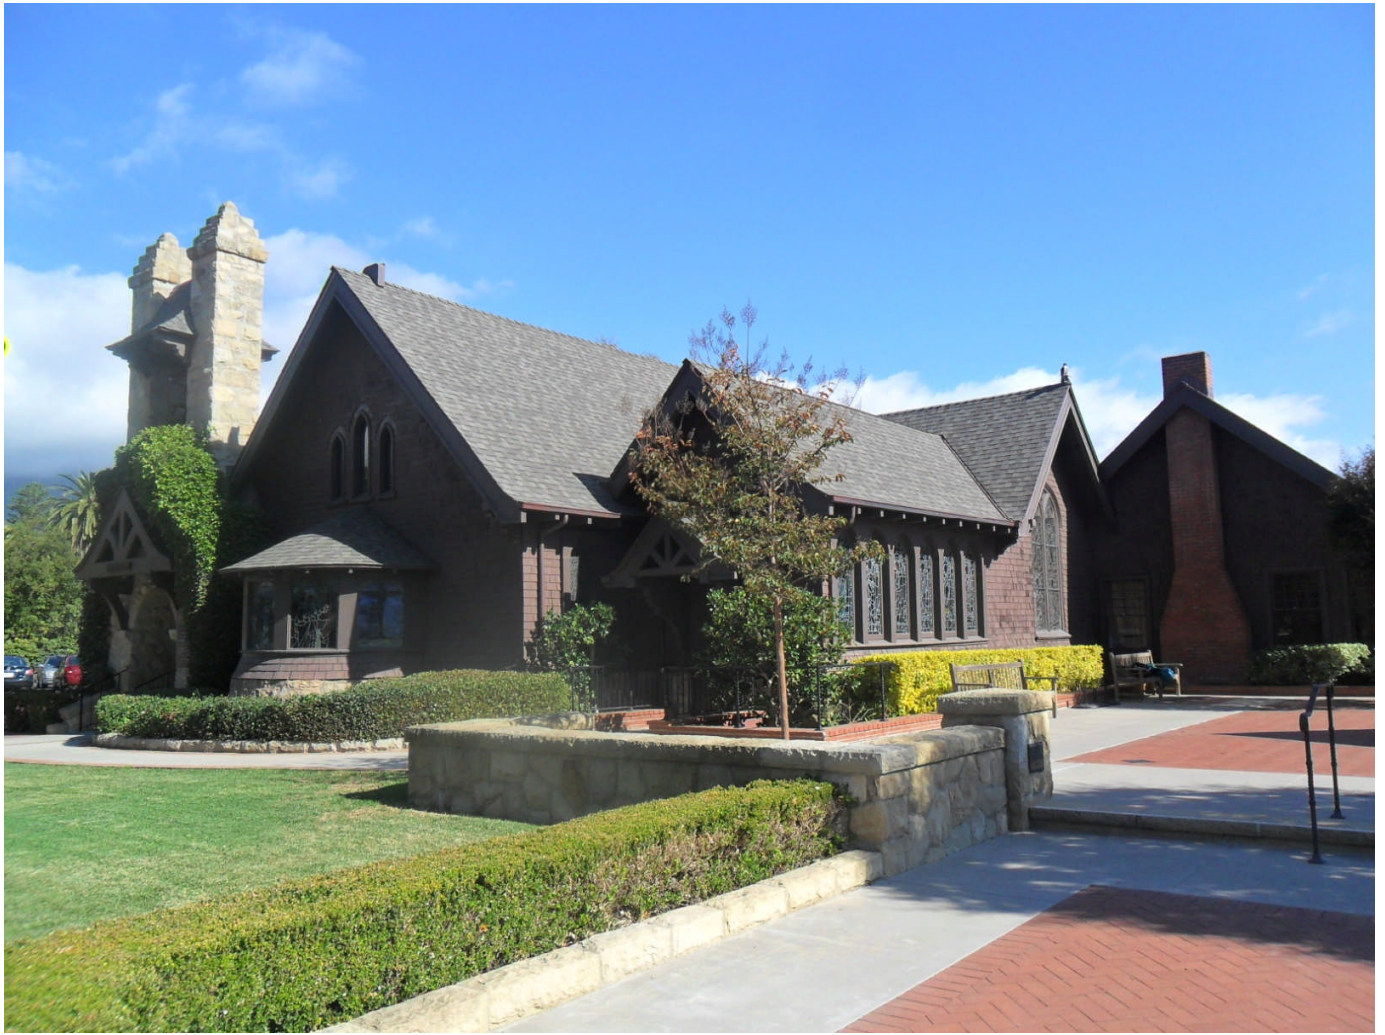
Figure 13
All Saints By-the-Sea Church at 83 Eucalyptus Lane in Montecito
North end of the west elevation (primary façade)

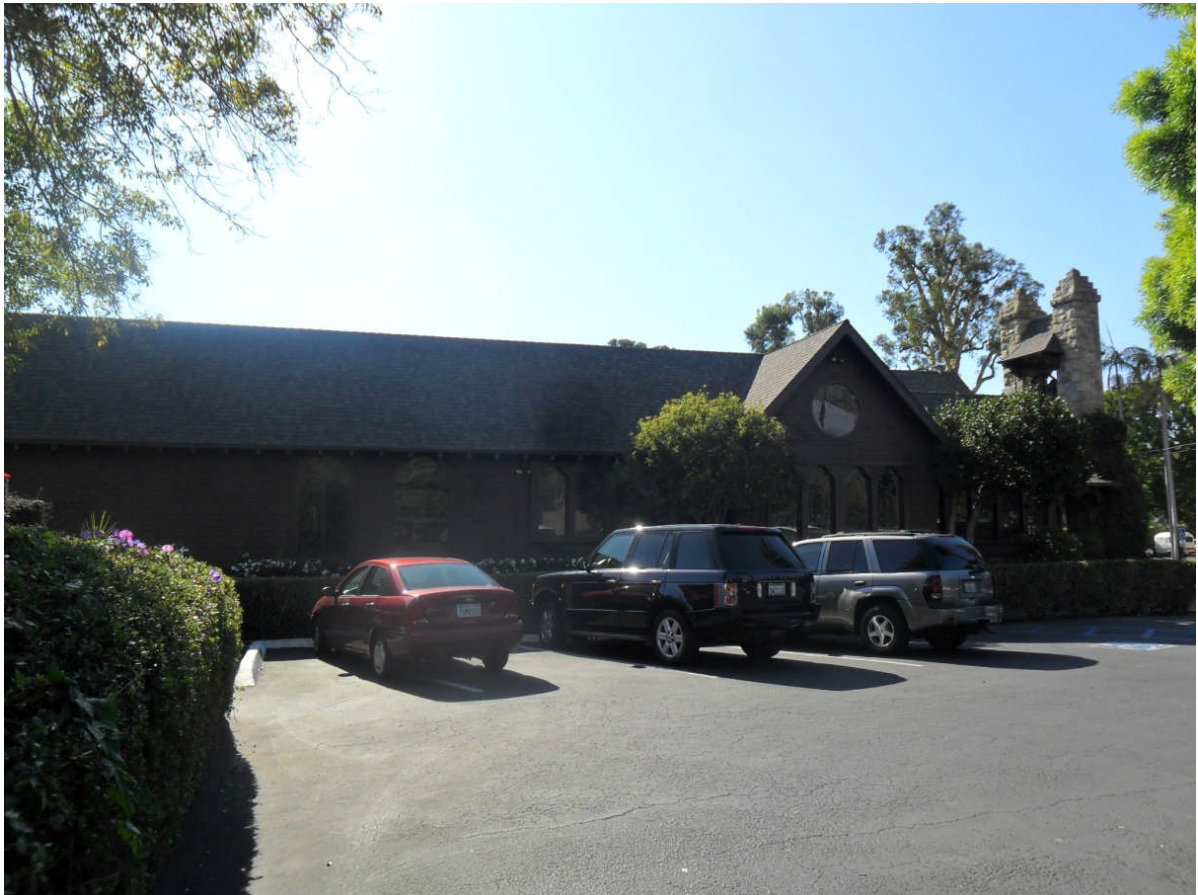
Figure 14
All Saints By-the-Sea Church at 83 Eucalyptus Lane in Montecito
west and south elevations, looking northeast

The south elevation is L-shaped in configuration and is flanked on its east by a projecting wing built in 1916 housing a study for the rector and a choir room (Figures 21 & 22 and see Figure 14). The nave and aisles of the church are capped by a steeply-pitched side-gable roof; its fenestration is composed of stained glass windows set in arched reveals. The choir room and study are capped by a steeply-pitched side gable roof. A porch, capped by a front-gable roof supported by corbelled wood timbers, shelters a glazed wood-paneled door that provides access to the choir room.

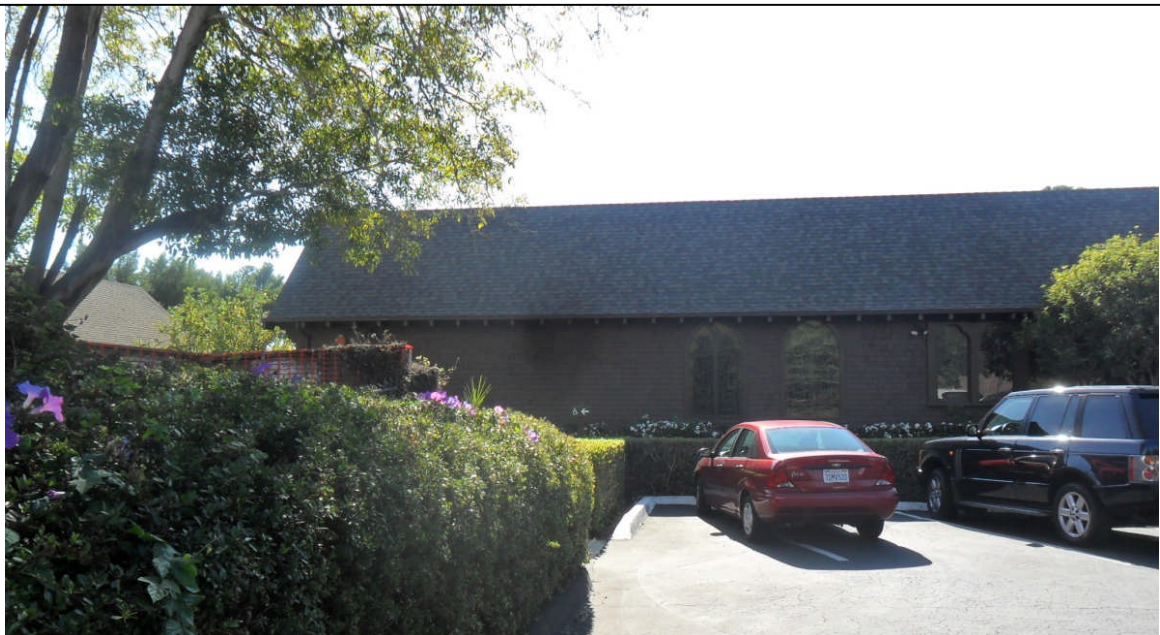
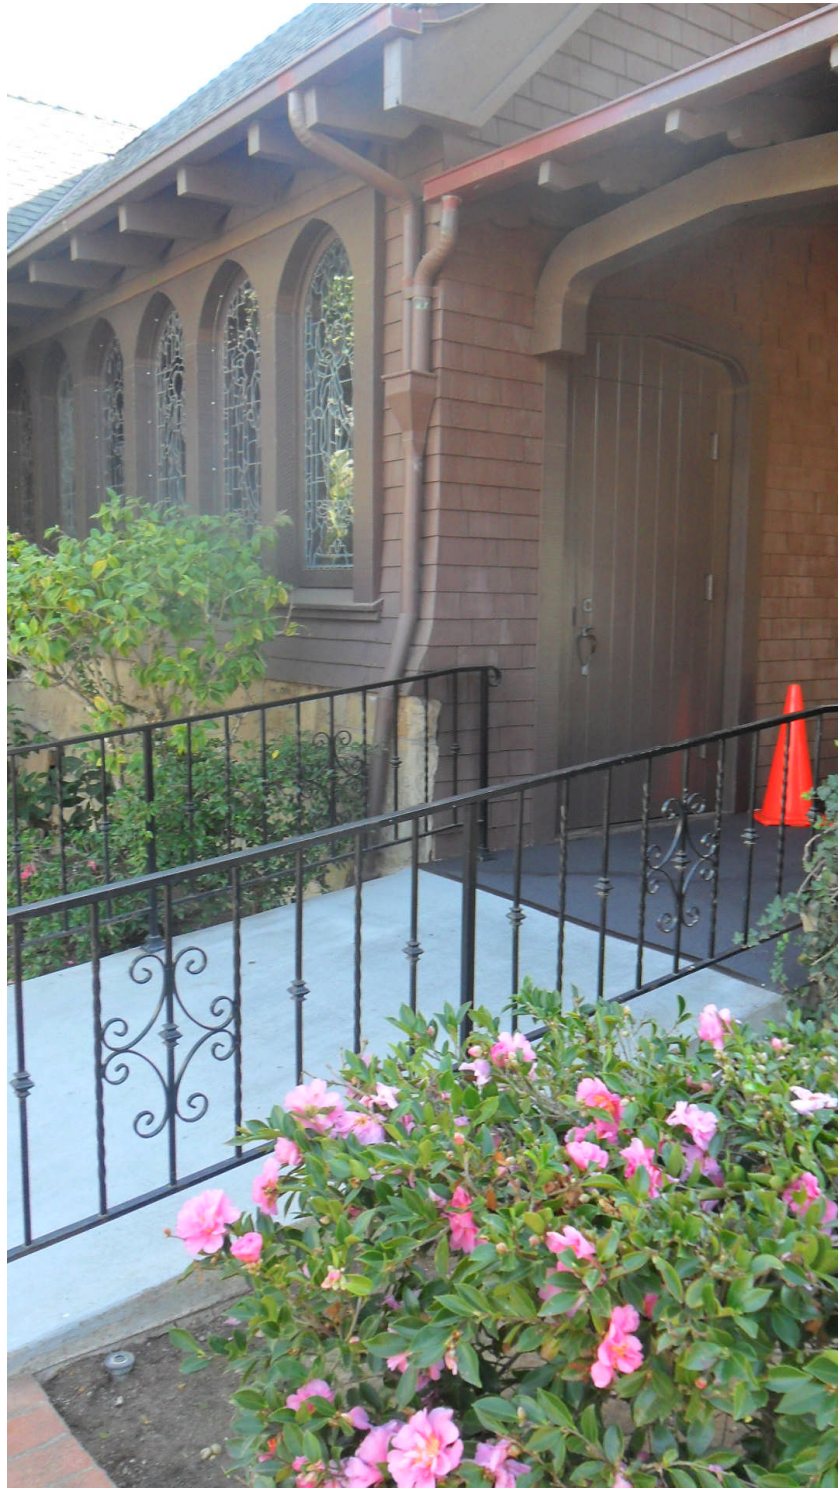
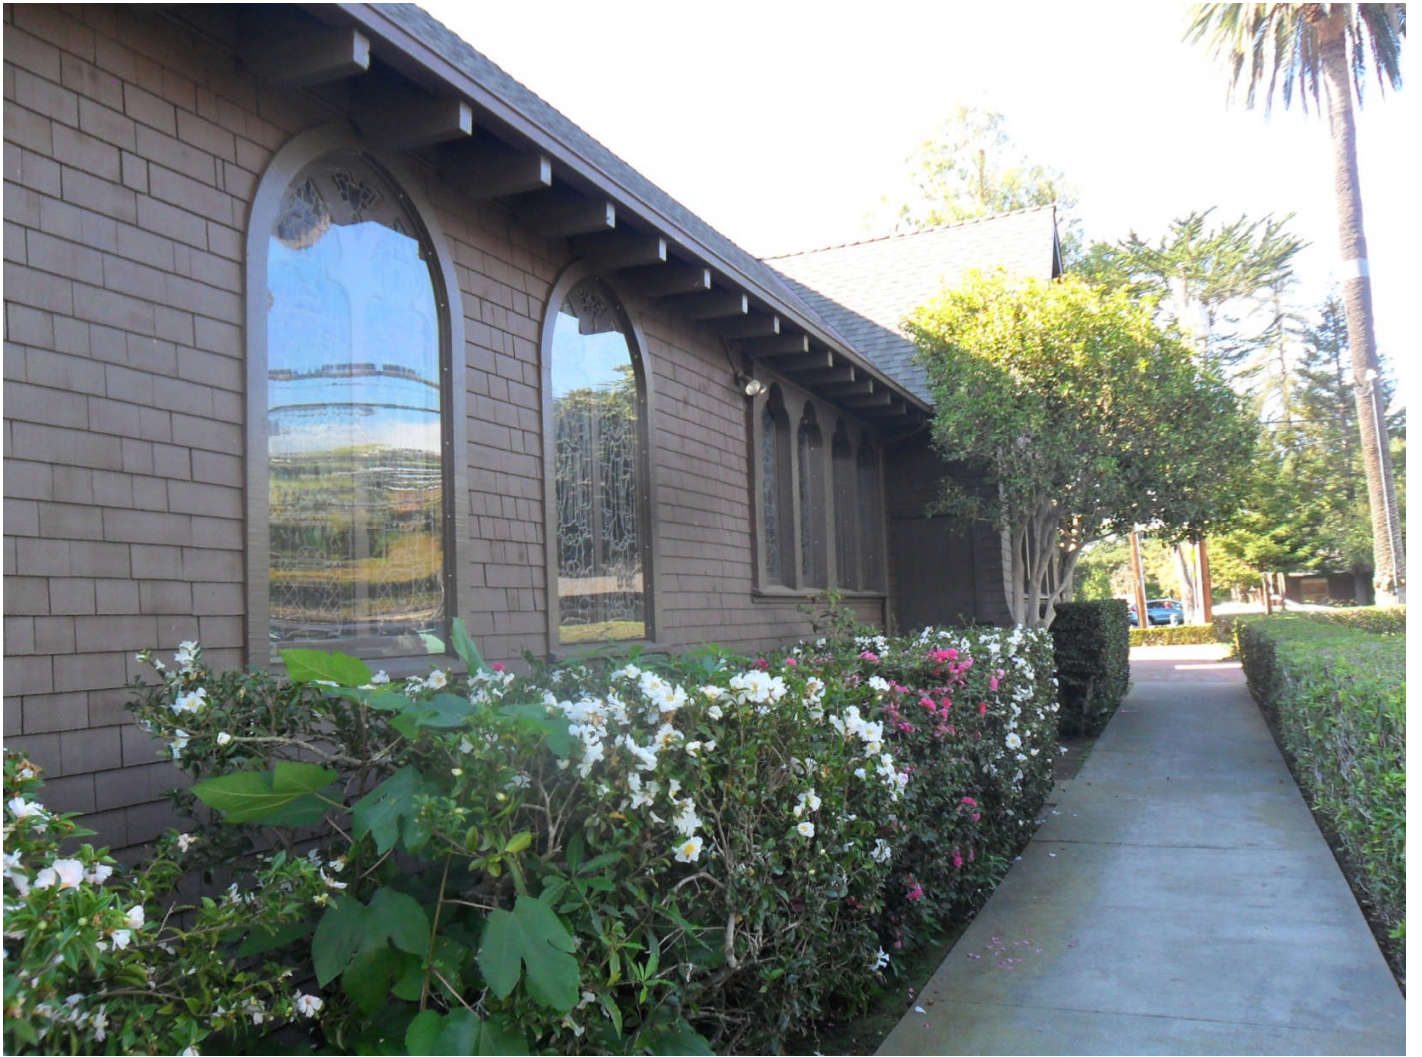
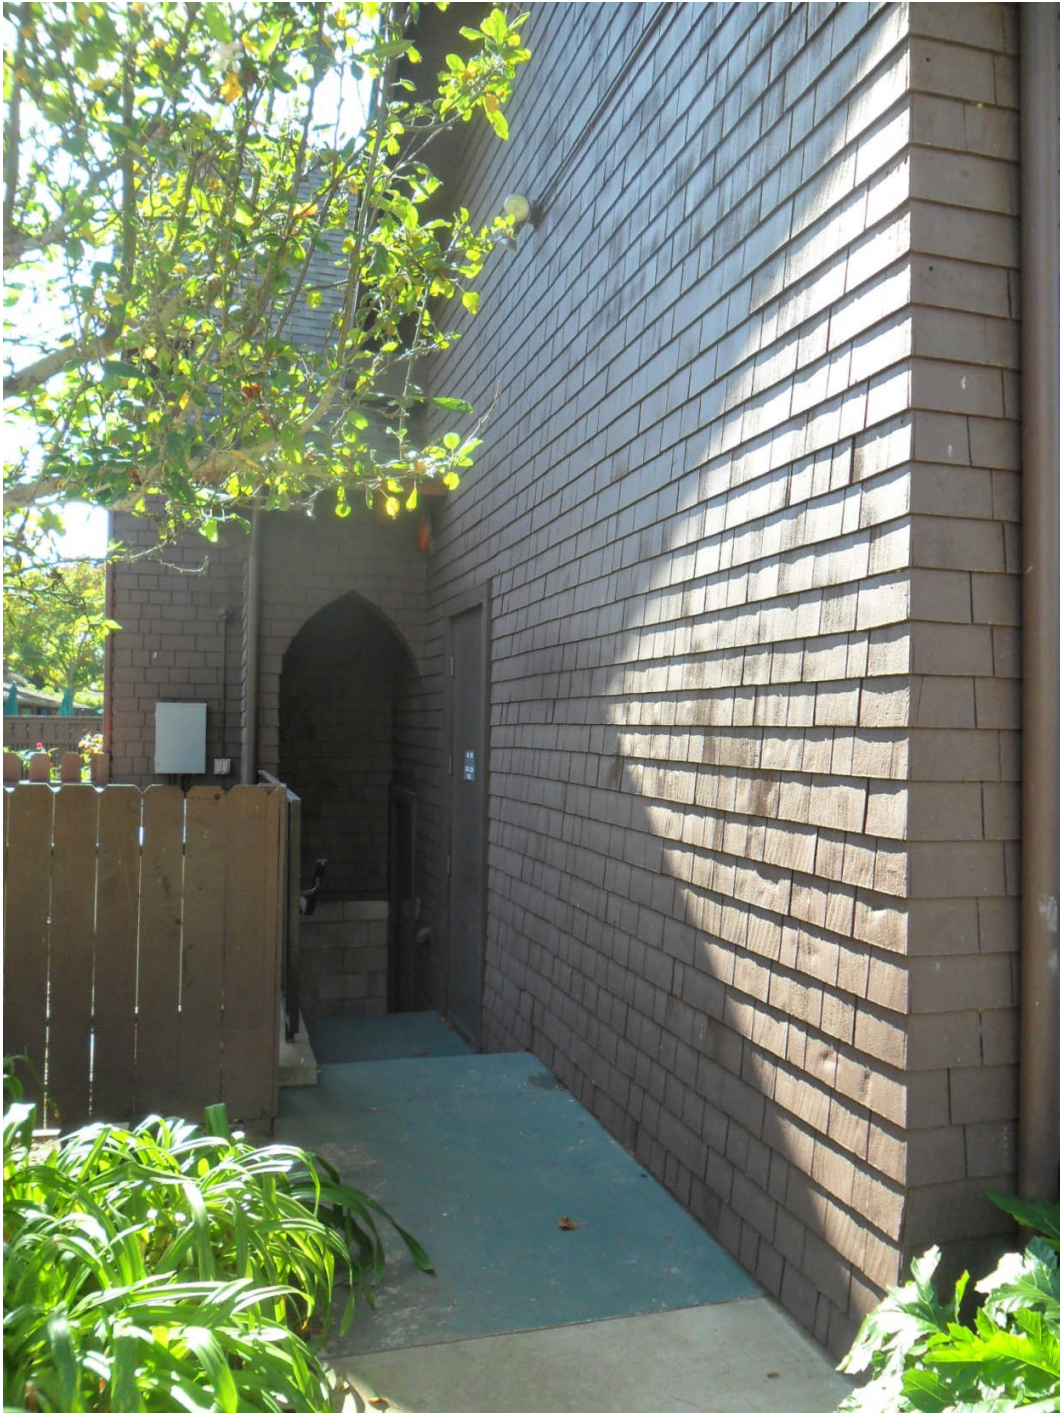
Figure 15
All Saints By-the-Sea Church at 83 Eucalyptus Lane, Montecito
North elevation
Looking southwest

Figure 16
All Saints By-the-Sea Church at 83 Eucalyptus Lane, Montecito
North elevation
Looking south

Figure 17
All Saints By-the-Sea Church at 83 Eucalyptus Lane, Montecito
North elevation (west end of elevation with entrance porch into church
Looking southwest

Figure 18
All Saints By-the-Sea Church at 83 Eucalyptus Lane, Montecito
North elevation
Looking west

The north elevation is L-shaped in configuration, with the entry porch and belfry flanked on their east by an extension to the nave added in 1921 that has a front-facing gable roof (Figures 15 -18). At its east end the addition is flanked by the remaining section of the original exterior wall of the church, which is capped by a side gable roof. This part of the elevation features a base of sandstone blocks capped by a shingled wall. Fenestration is comprised of a series of stained-glass windows set in arched openings. A circular stained glass window, added in 1921, is set in the gable end of the wing.

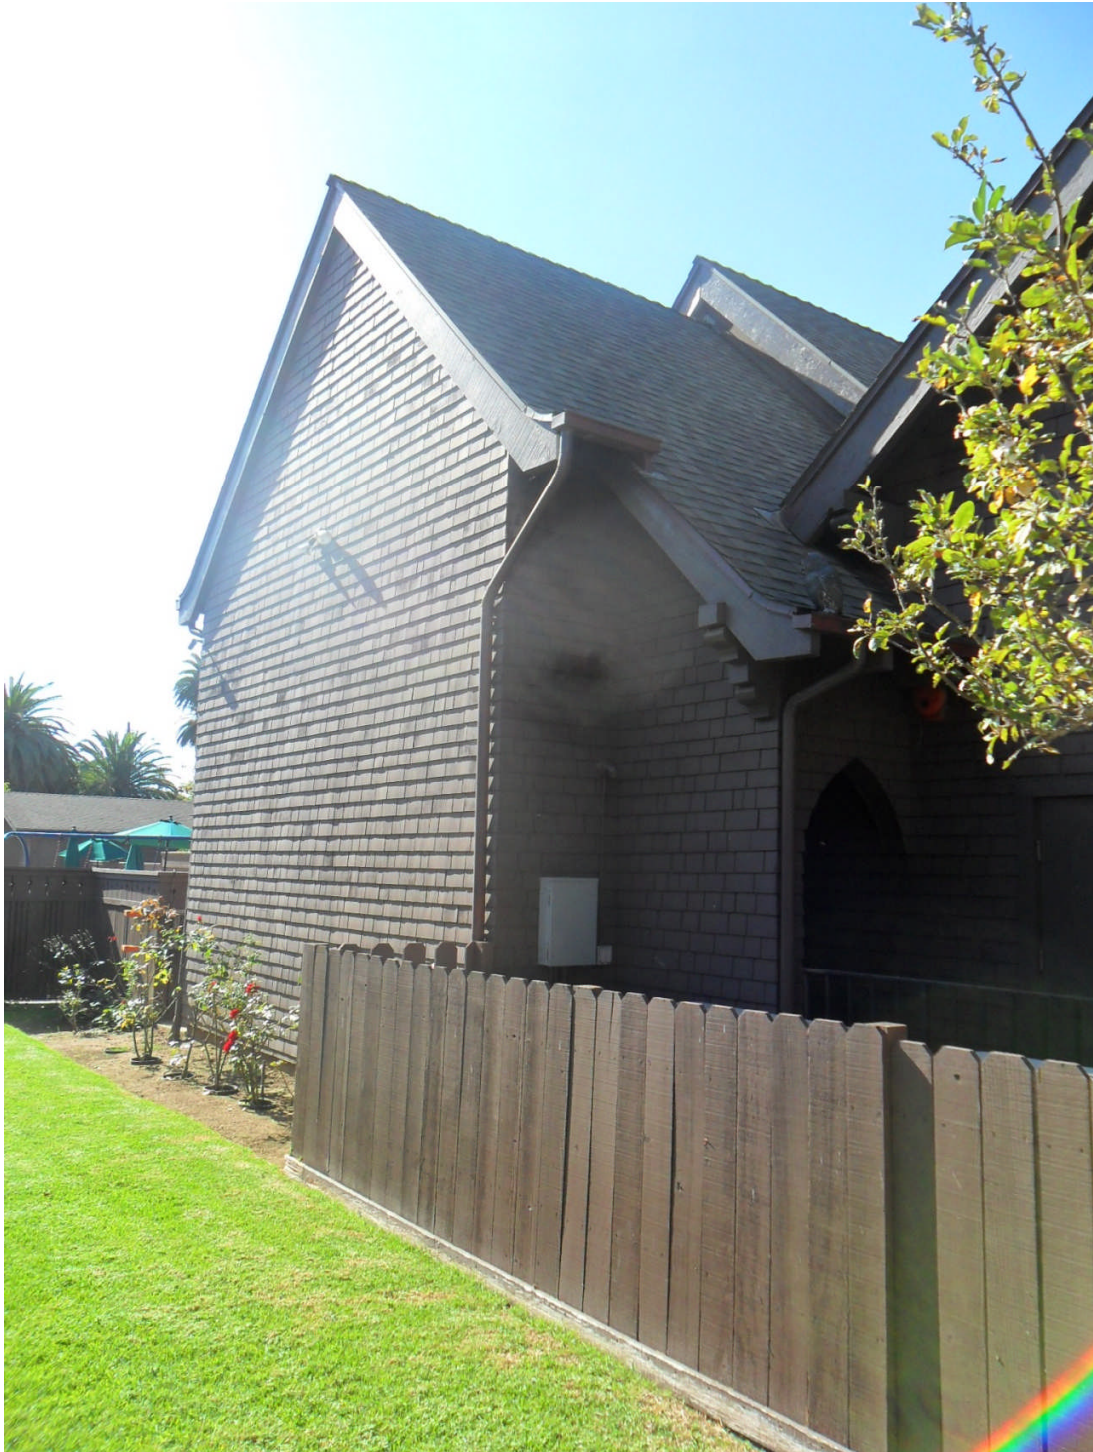
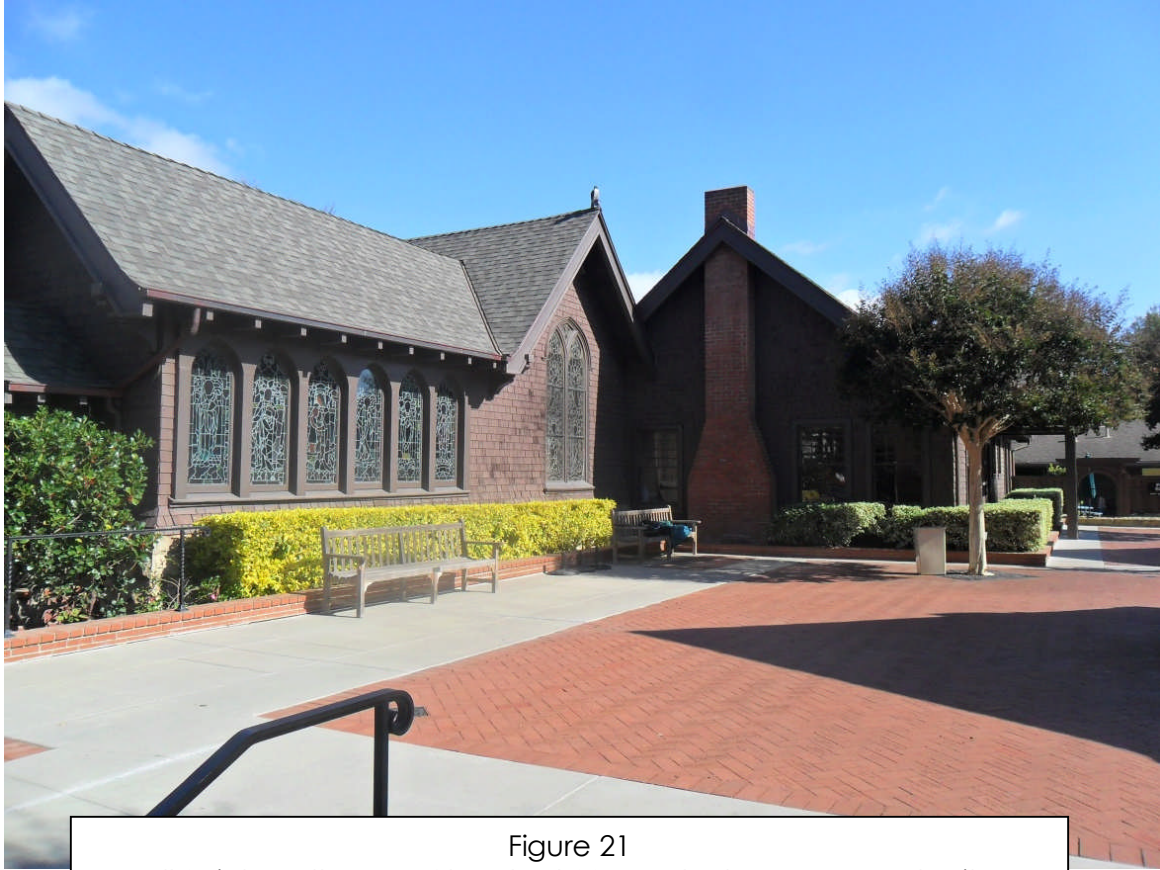
Figure 19
All Saints By-the-Sea Church at 83 Eucalyptus Lane, Montecito
East Elevation, north end
Looking south

Figure 20
All Saints By-the-Sea Church at 83 Eucalyptus Lane, Montecito
East elevation, south end of the elevation
Looking southwest

the vestry and on its north by the slightly recessed end of the 1921 addition to church (Figures 19 & 20). The entire east elevation is clad in wood shingles. Fenestration is confined to a small entry door accessed through a Gothic style ogee arch opening; set in a slight projection, it comprises the east end of the sanctuary.

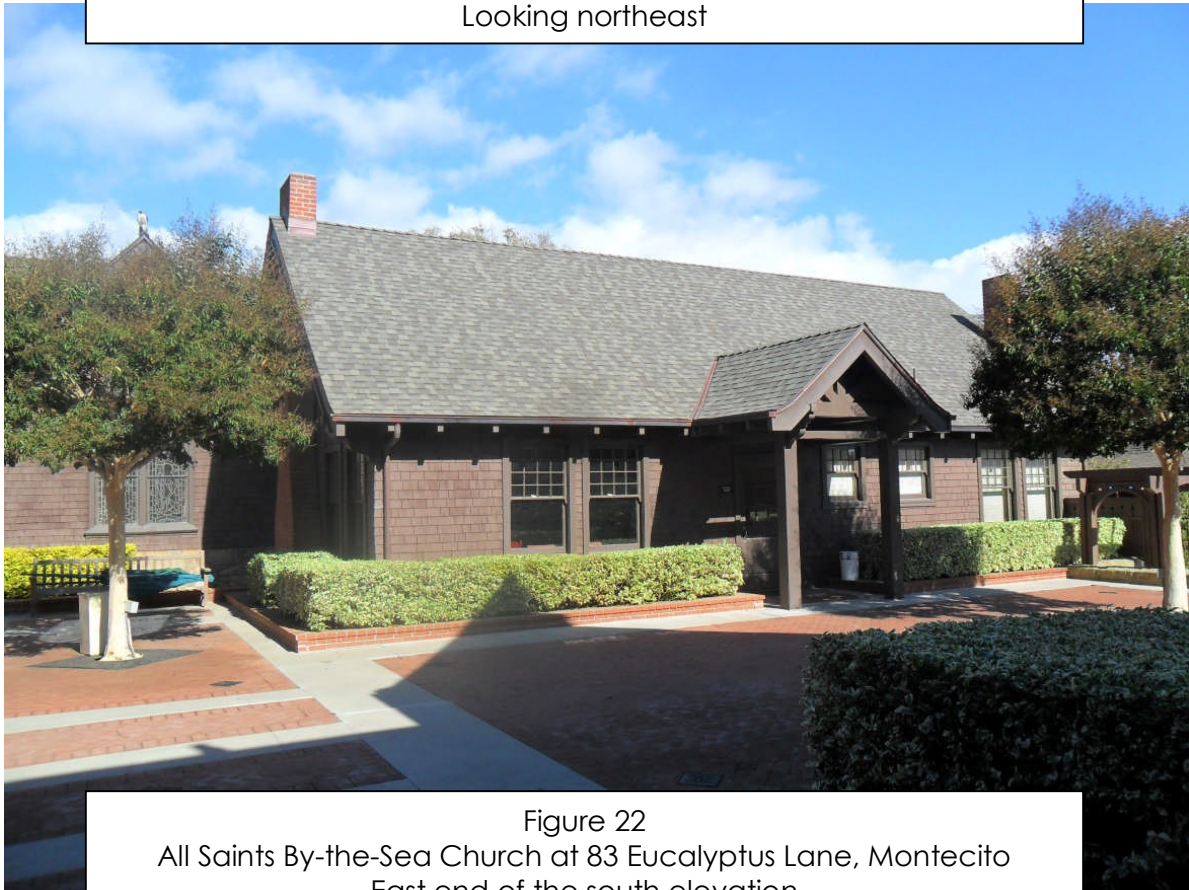
Figure 21
All Saints By-the-Sea Church at 83 Eucalyptus Lane, Montecito
West end of the south elevation
Looking northeast

Figure 22
All Saints By-the-Sea Church at 83 Eucalyptus Lane, Montecito
East end of the south elevation
Looking northeast
